DENEY RAPORU

TEST REPORT

: Powered Smoke and Heat Exhaust Axial Fan – FAF-65

Fire resistance test, in conformity with the general requirements of standards EN 1363-1:2020, with substitute or additional methods of standard EN 1363-2:1999 and with the particular requirements of standard EN 12101-3:2015 "**Smoke and heat control systems - Part 3: Specification for powered smoke and heat exhaust ventilators - Annex C: Test method for the determination of fire resistance of powered smoke and heat control ventilators**"

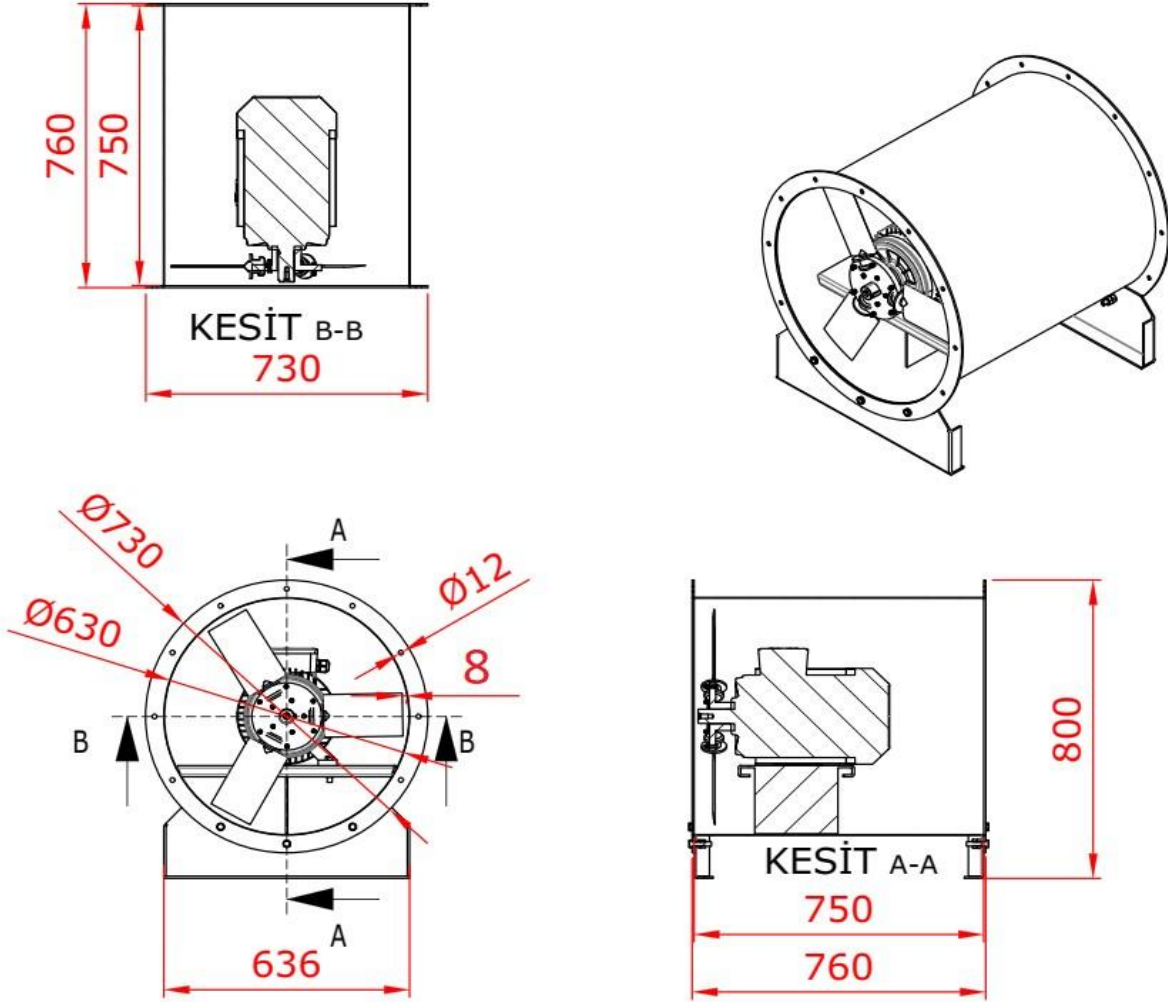
Figure 1: fan carcass details

3.2.1.1. Carcase

Material : St 44 steel

Dimensions :

- Overall diameter : 730 mm
- Inner diameter : 630 mm
- Outside length : 750 mm
- Wall thickness : 5 mm
- Carcase support : 2 steel plate legs were used to fix the fan frame.
 - Steel plate dimensions : 636 x 40 x 192 x 5 mm (w x d x h x t)
 - Fixing : M20 steel screws. (6 pcs.)

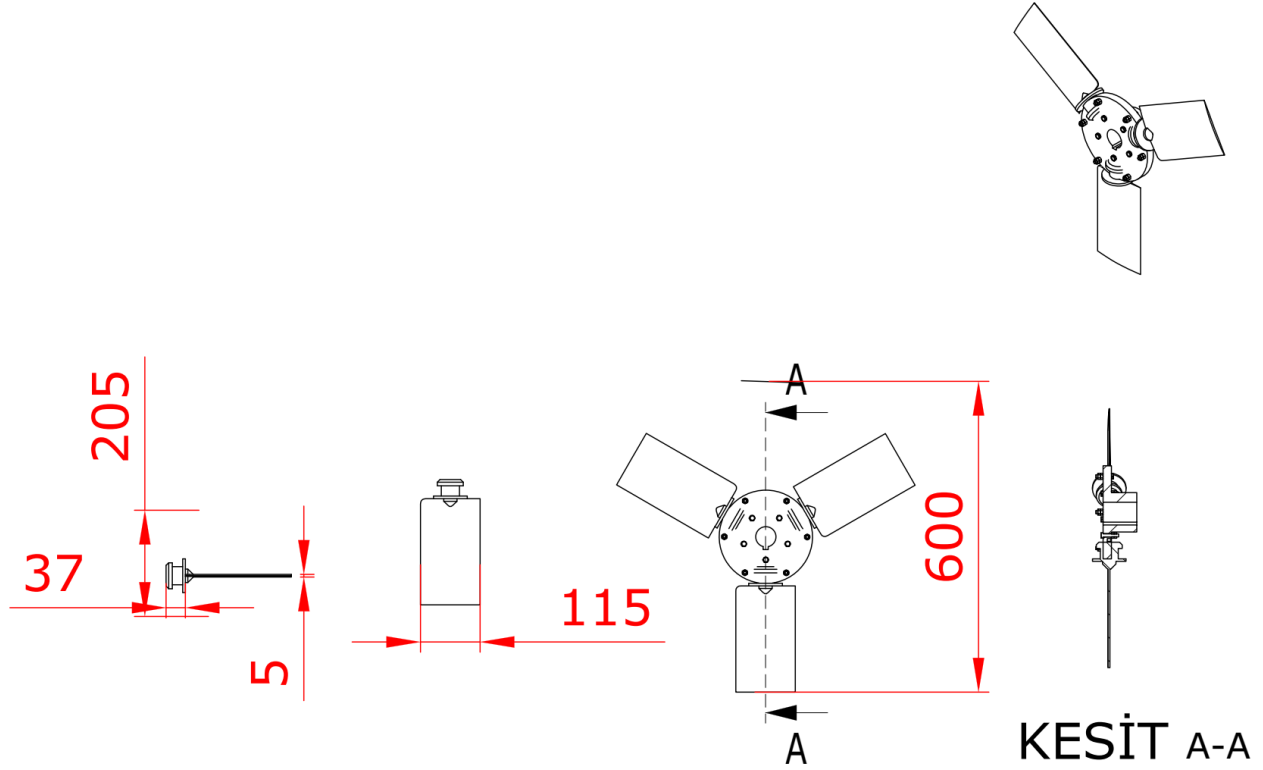
Figure 2: Impeller details

3.2.1.2. Impeller:

Material : Special aluminium alloy (AlSi12Cu1(Fe))

Number of blades : 3

Nominal tip gap : 8 mm

Nominal dimensions :

- Overall diameter : 600 mm
- Blade length : 205 mm
- Blade thickness : 5 mm
- Fastening : Each impeller placed inside to the hub casing and fixed with 5 pcs. nut.

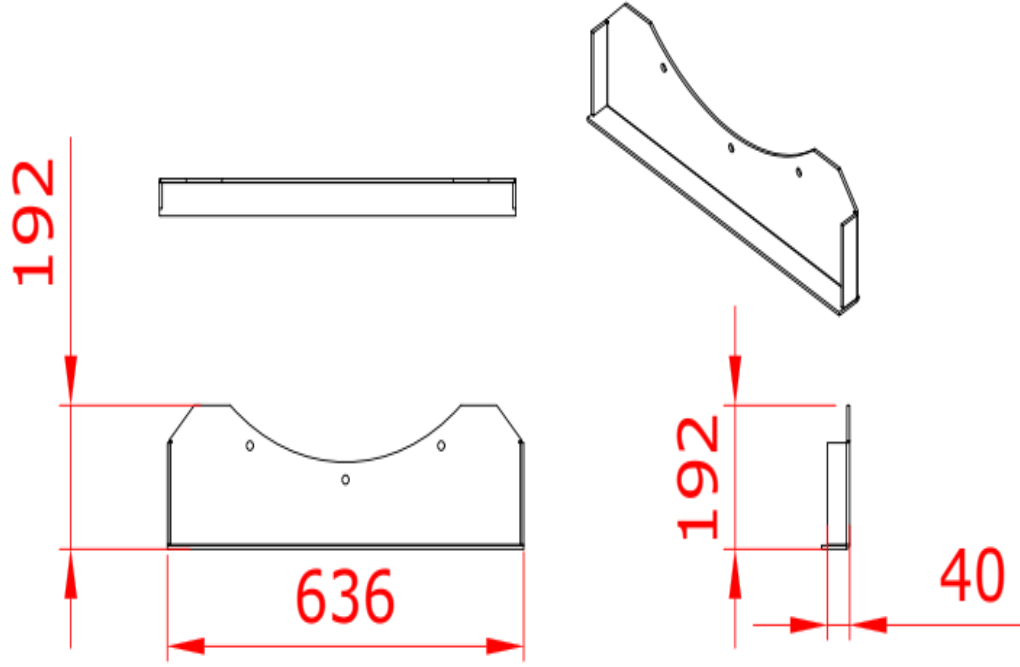
Figure 3: fan carcass details

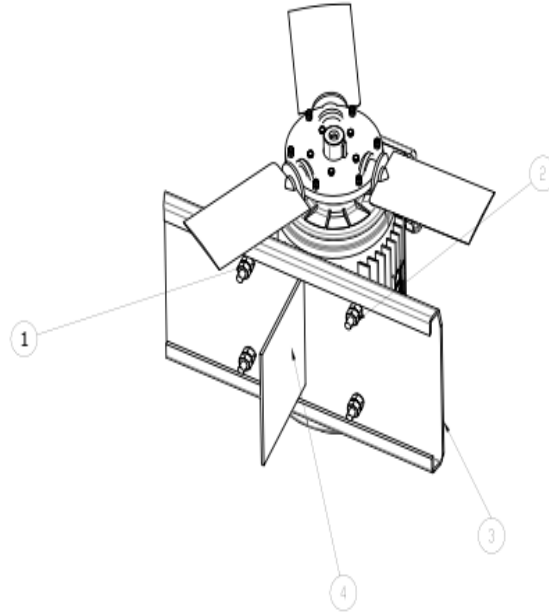
Figure 4: Motor connecting details

3.2.1.4. Motor

Model number : GAMAK-GM2ED 132 S 2a
Rating : Motor Insulation H, Protection class IP55, Temperature rise class B (ΔT 80K)
Carcase : 132S
Speed : 2900 rpm
Electrical information : 400 V, 50 Hz, 5,5 kW, 10,3 A, $\cos\Phi$: 0,89
Application : Uninsulated, smoke and heat exhaust.
Bearing type : Ball bearing-ZZ
Class of fit : C4
Arrangement : Not locked
Lubricant : KRYTOX CORRUGATOR 226 FG-DUPONT

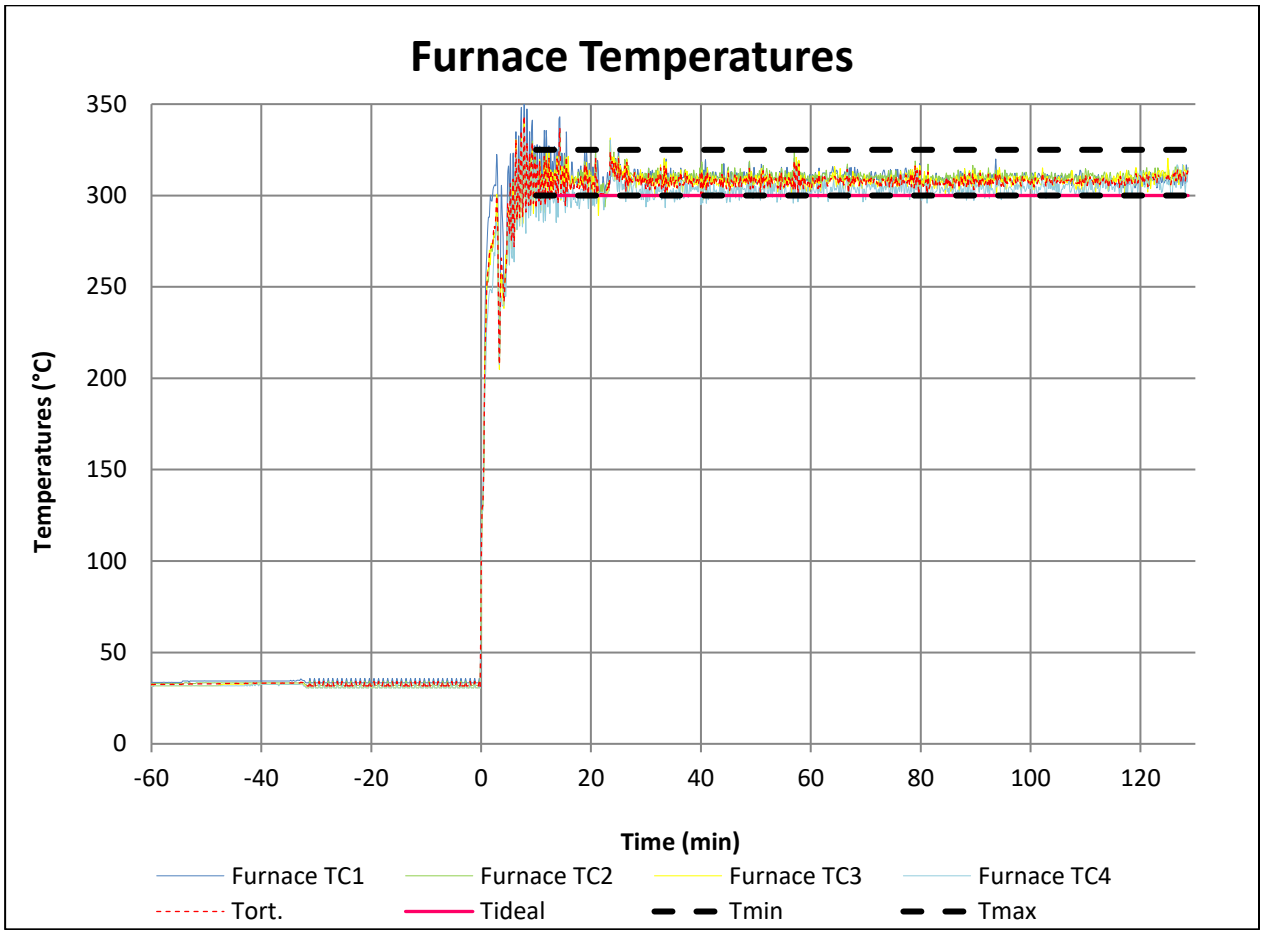
Figure A1: Furnace temperatures

- Air temperatures at the intake plane of the fan (Furnace TC1 to Furnace TC4) (see figure A1).
- Ambient temperature in the laboratory (see figure A3).
- Static pressure at the intake plane of the fan (see figure A2).
- Surface temperatures on the motor carcass (See Figure B2)
- Current of the motor (see figure B3)
- Supply voltage of the motor (see figure B4)
- Electrical power of the motor (see figure B5)
- The positions of the thermocouples on motor carcass are given in figure B1.

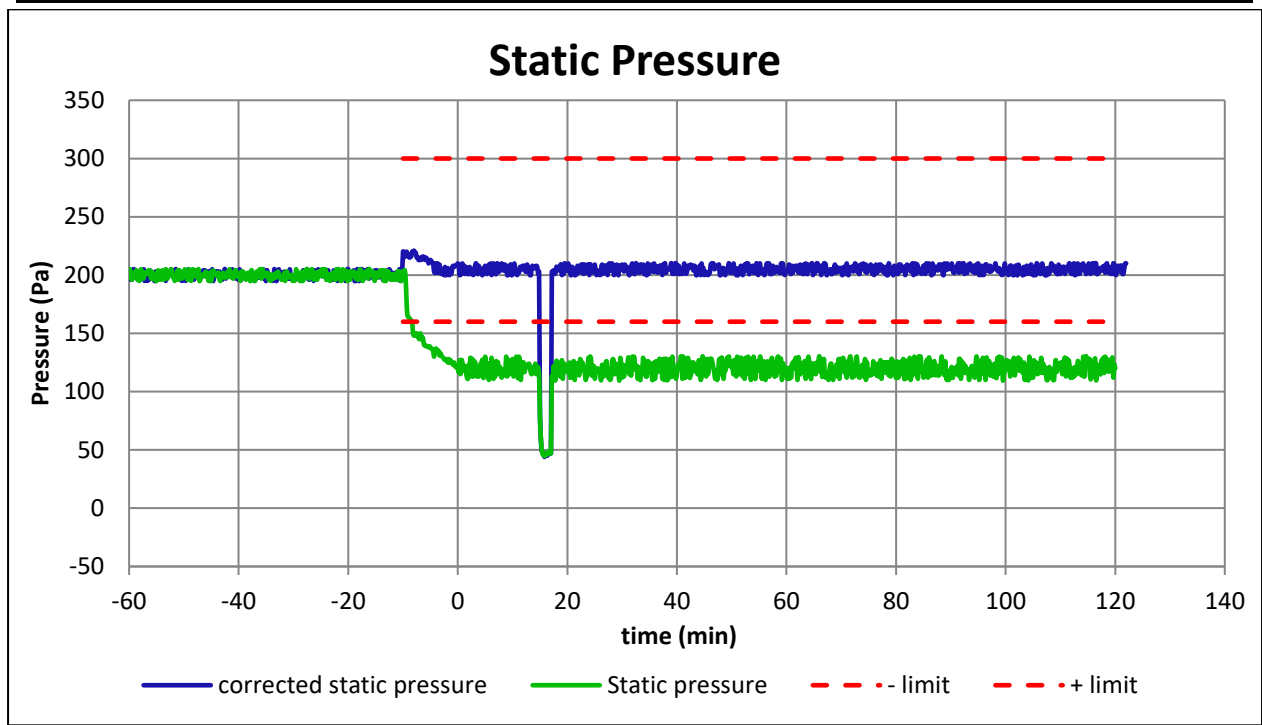
Figure A2: Static pressure of fan

| Functionality, (F) – Static pressure – Motor | No failure (- %5,88) No failure |

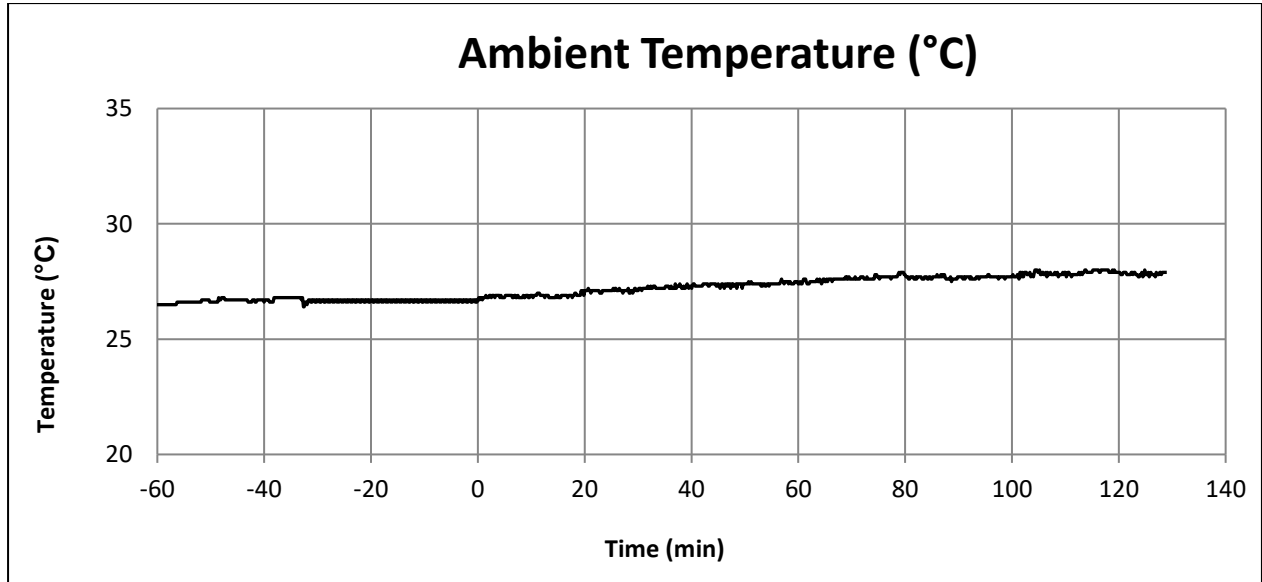
Figure A3: Ambient temperature at laboratory

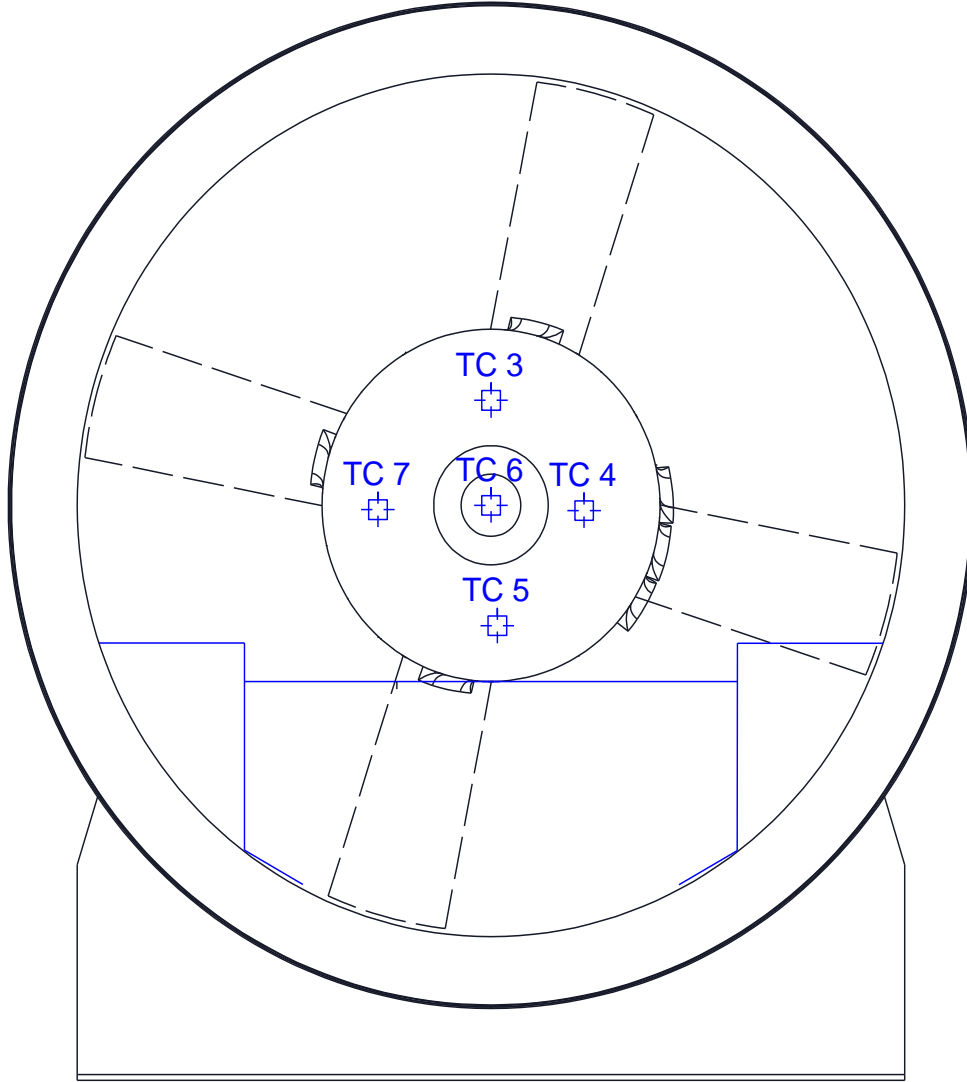
Figure B1: Locations of thermocouples on the motor carcass

- Static pressure of the fan: Piezometric ring connected to differential pressure transmitter
- Electrical measurement: Power analyser
- Temperature measurement on motor carcass: Fibre-glass insulated Type K Thermocouple

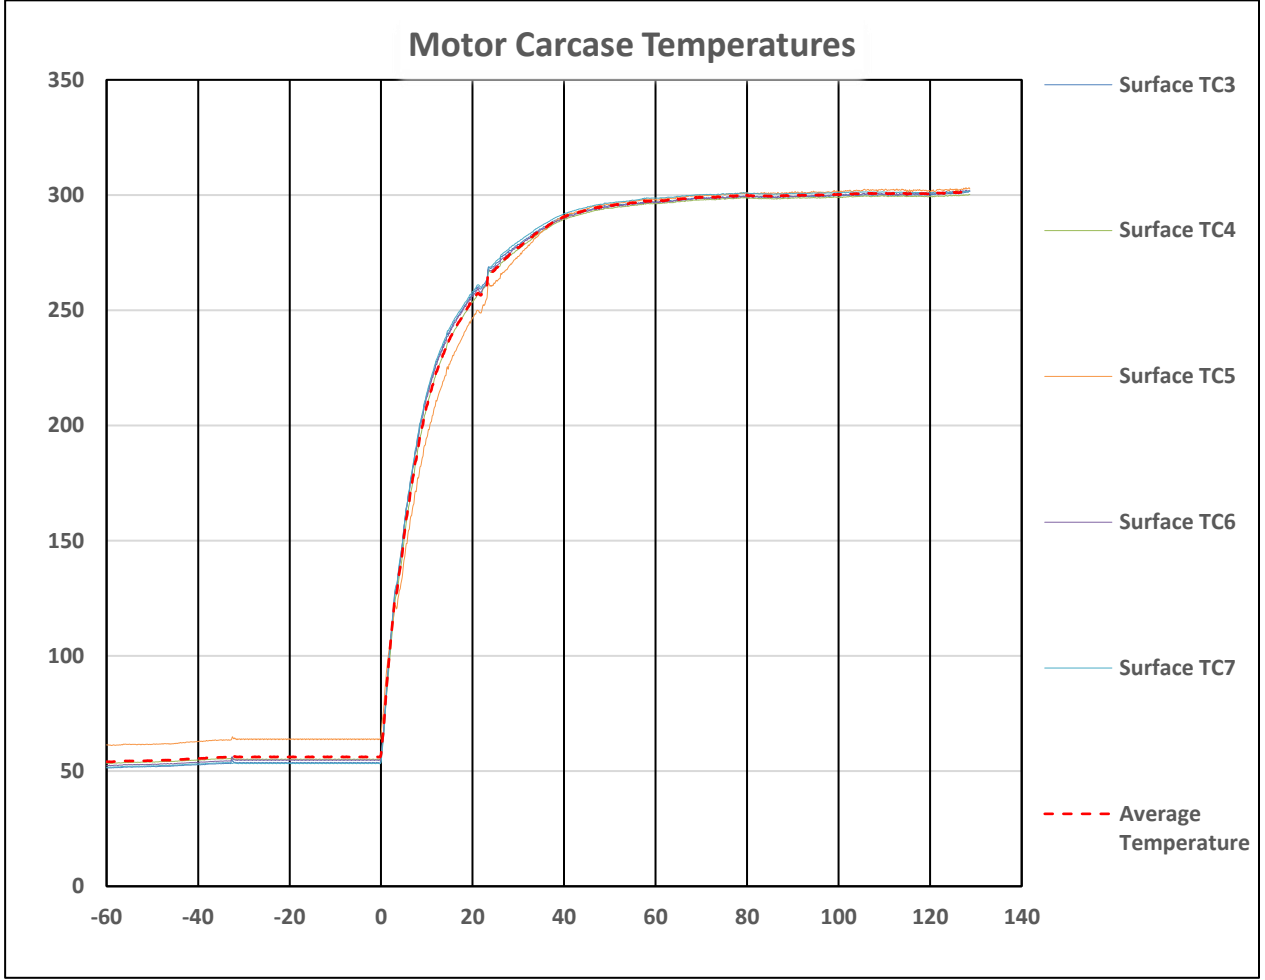
Figure B2: Surface temperatures on motor carcase

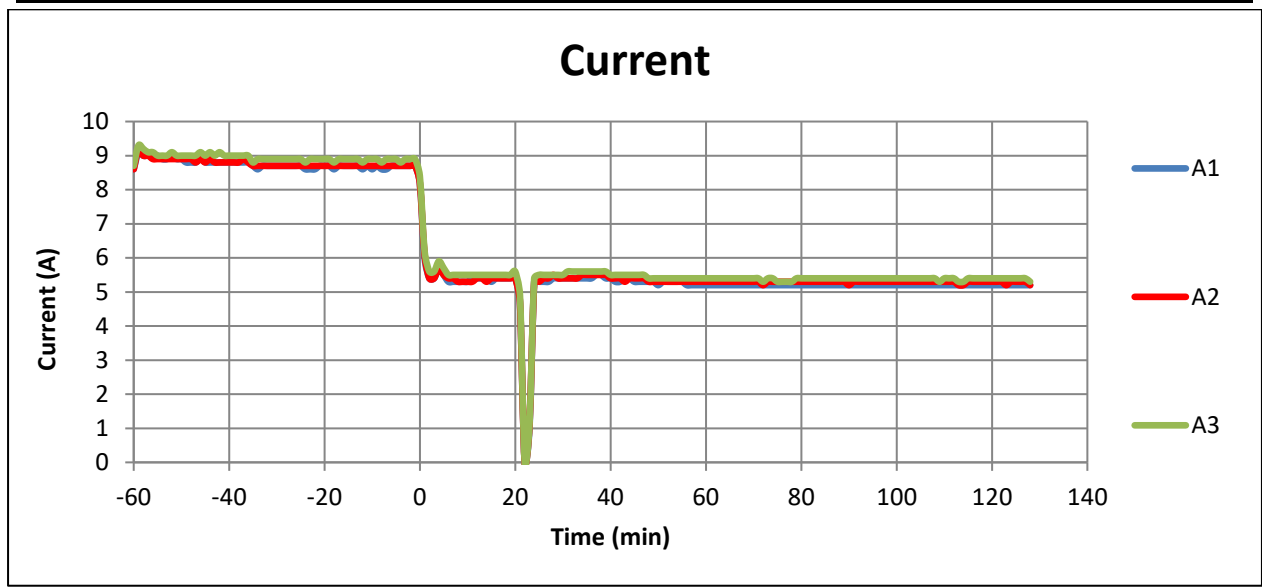
Figure B3: Motor current reading during test

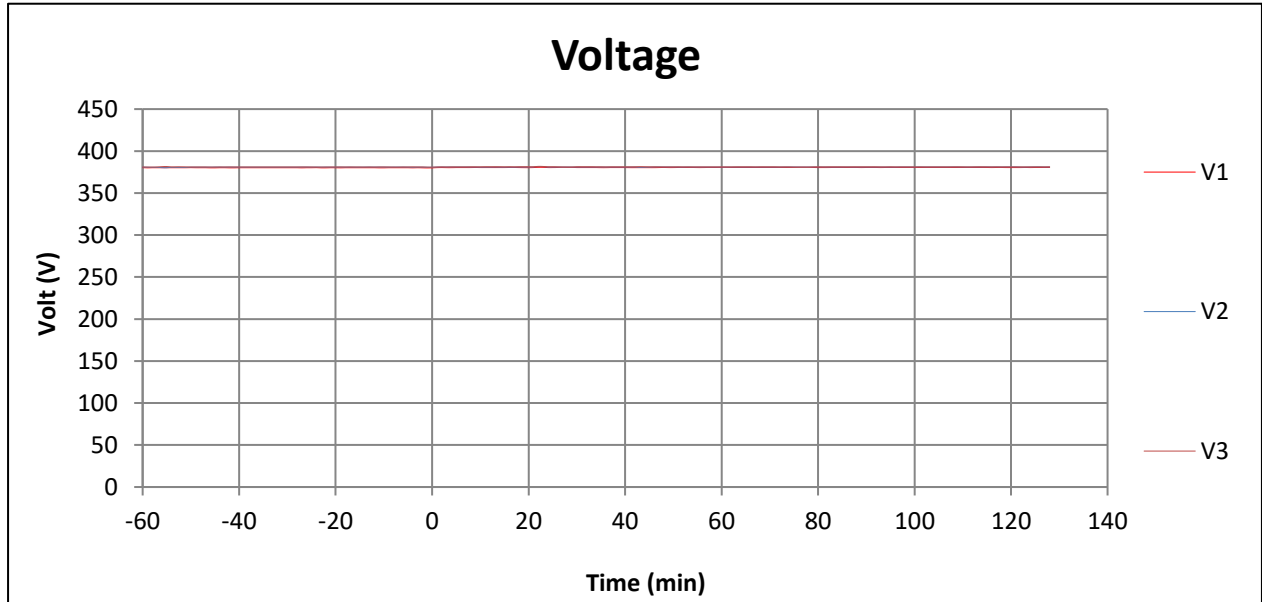
Figure B4: Motor voltage reading during test

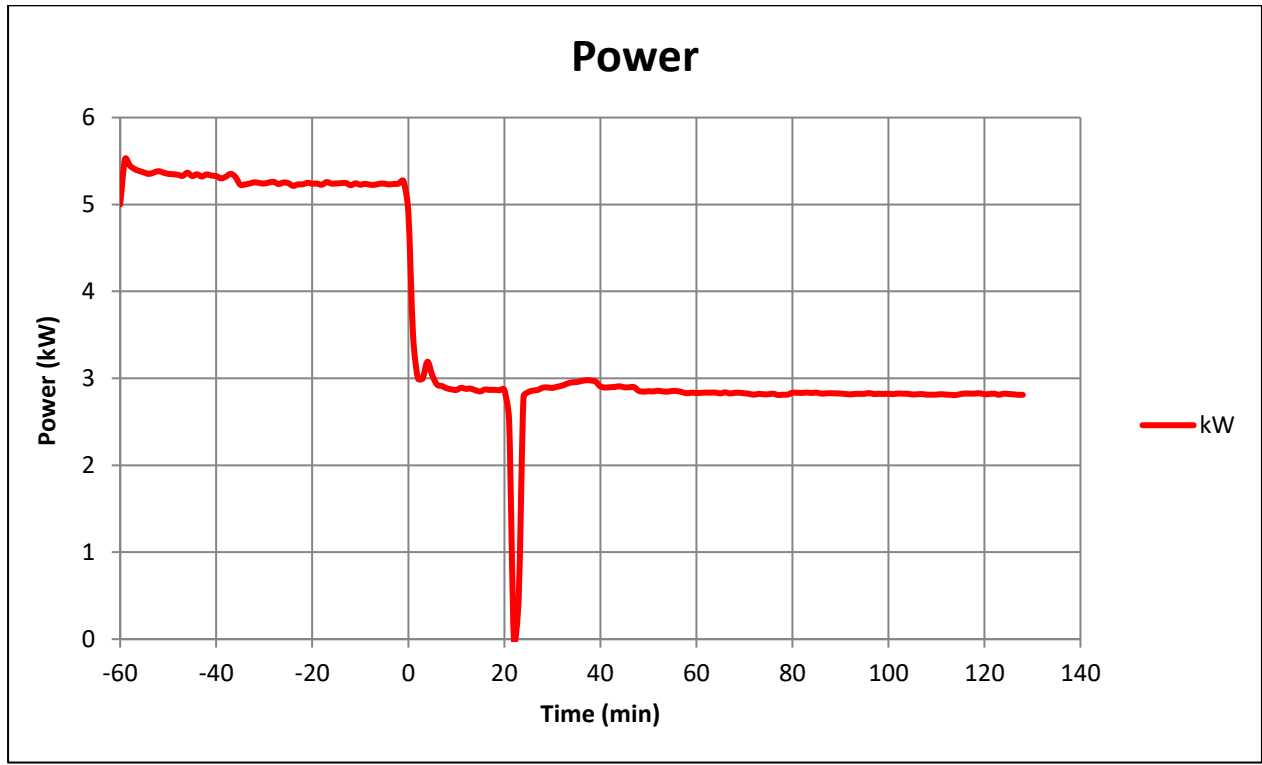
Figure B5: Motor power reading during test

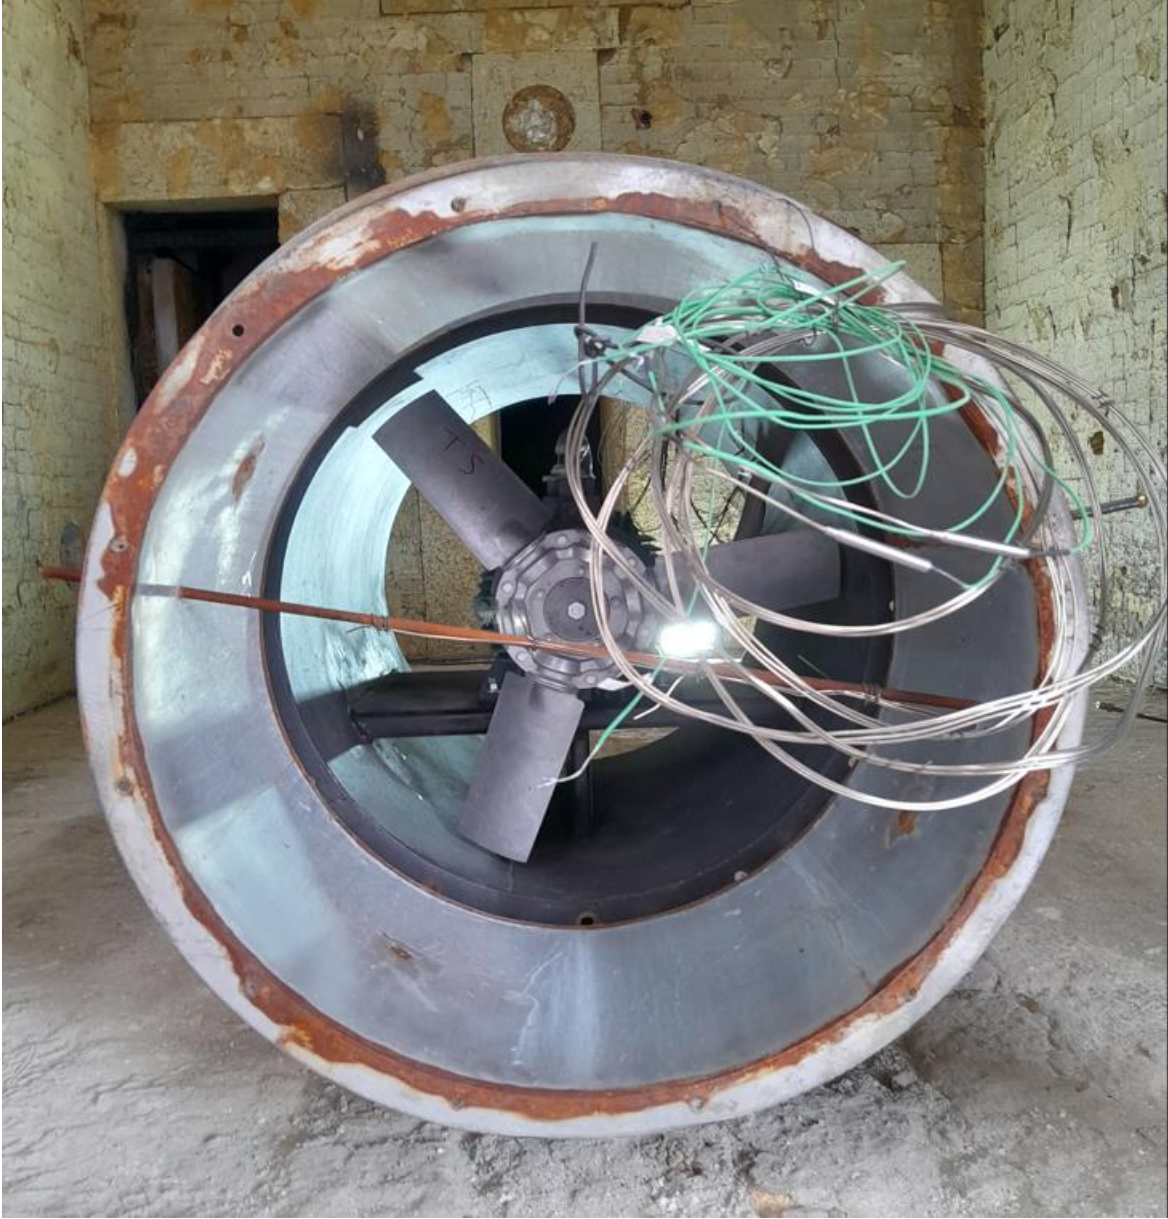
Photo C1: Front view of the specimen before the test

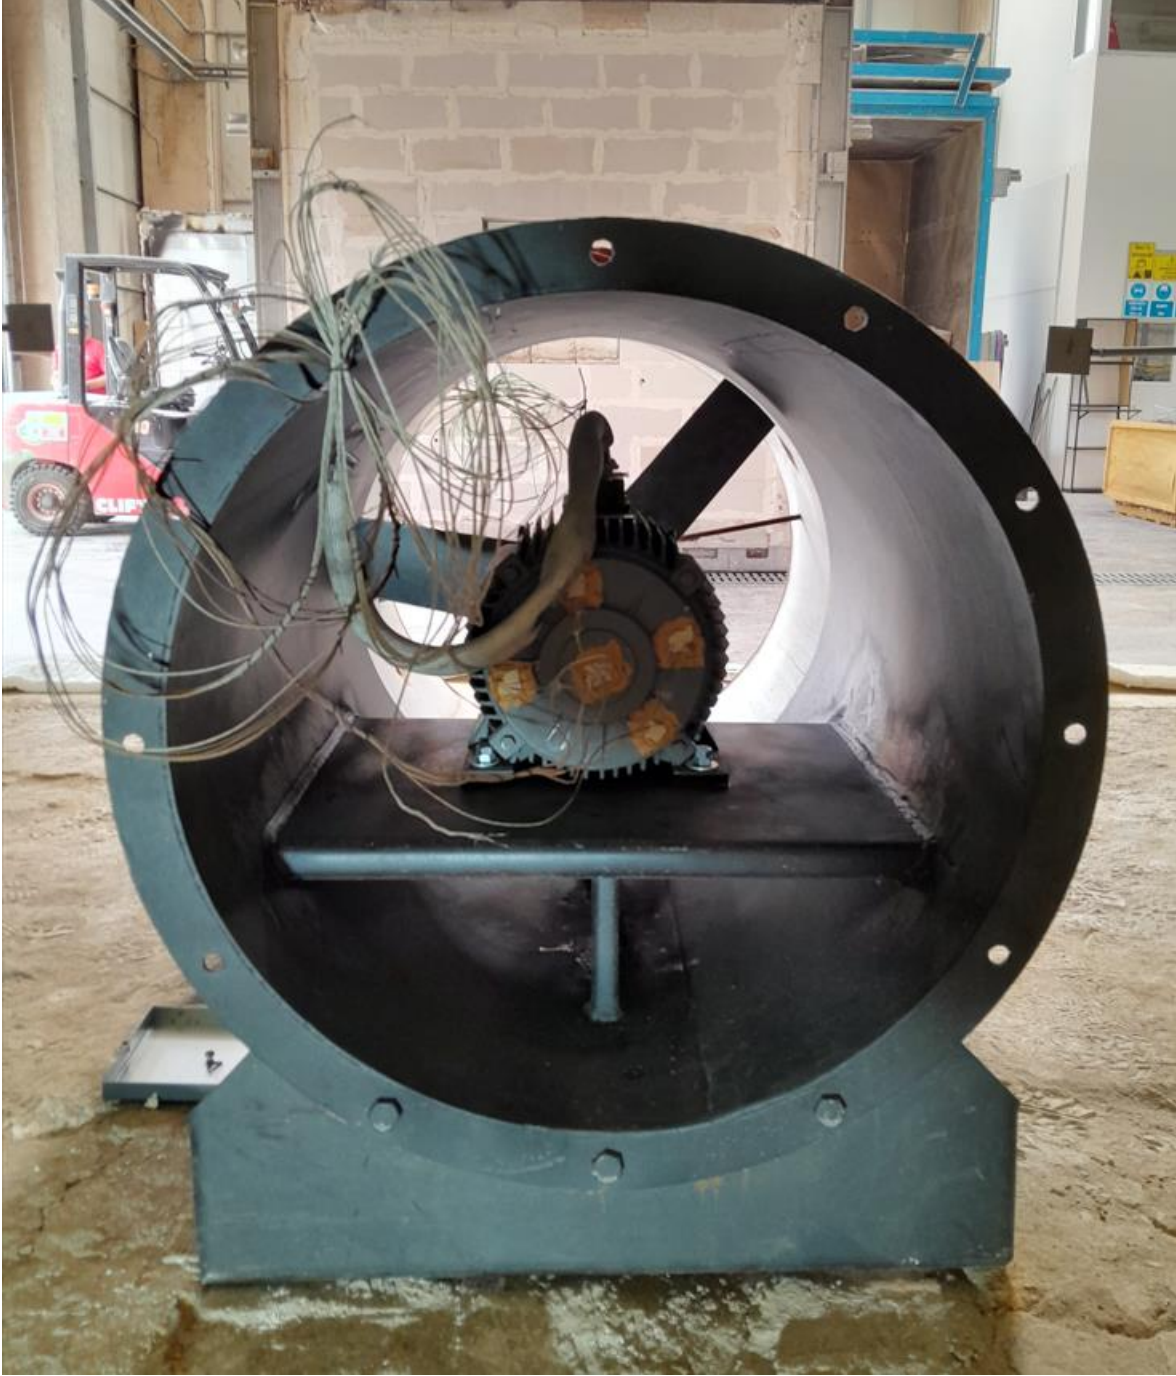
Photo C2: Rear view of the specimen before the test

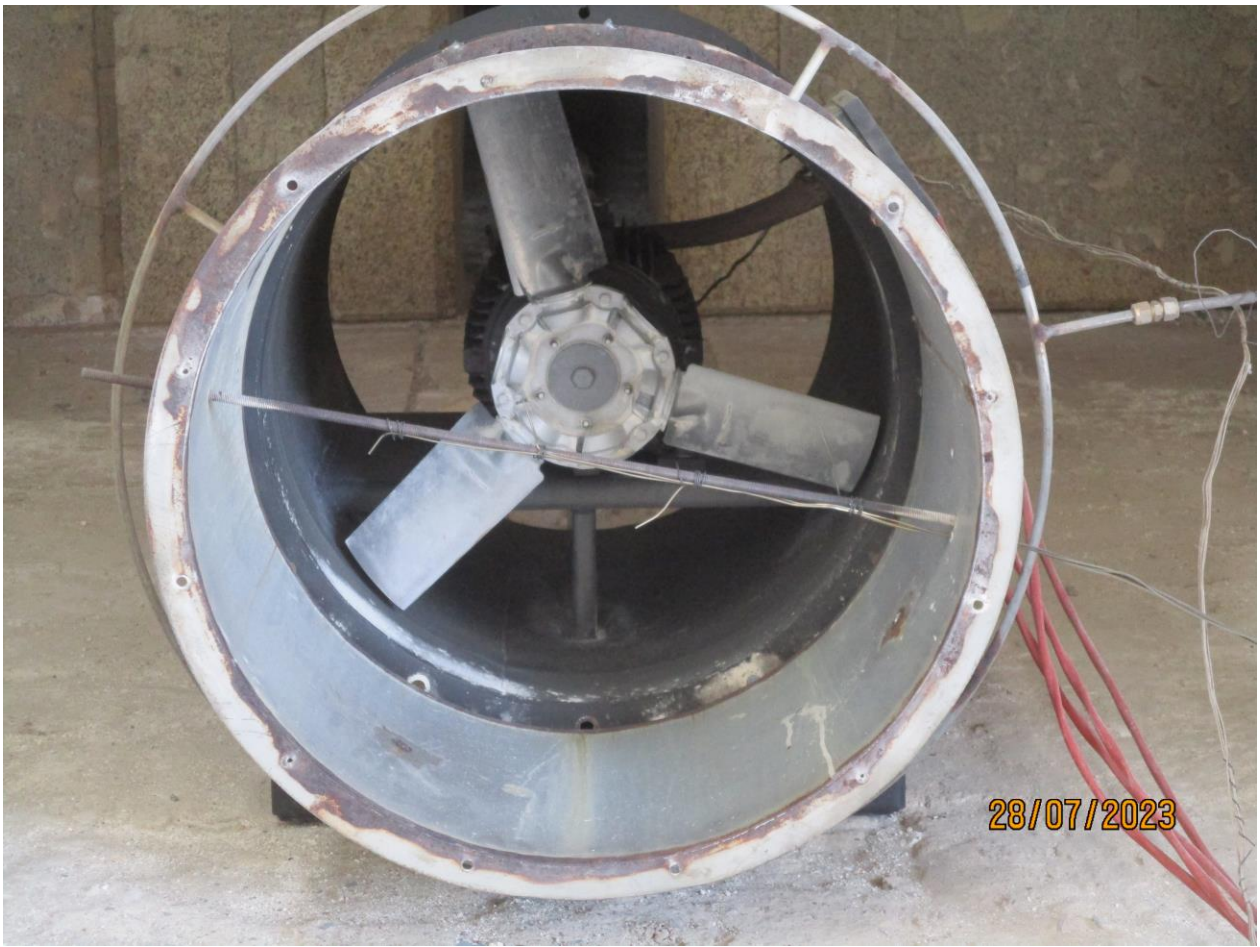
Photo C3: Front view of the specimen after the test
