DENEY RAPORU

TEST REPORT

Numunenin adı ve tarifi : Powered Smoke and Heat Exhaust Axial Fan – **FAFJ-35**
Name and identity of test item

Fire resistance test, in conformity with the general requirements of standards EN 1363-1:2020, with substitute or additional methods of standard EN 1363-2:1999 and with the particular requirements of standard EN 12101-3:2015 "**Smoke and heat control systems - Part 3: Specification for powered smoke and heat exhaust ventilators - Annex C: Test method for the determination of fire resistance of powered smoke and heat control ventilators**"

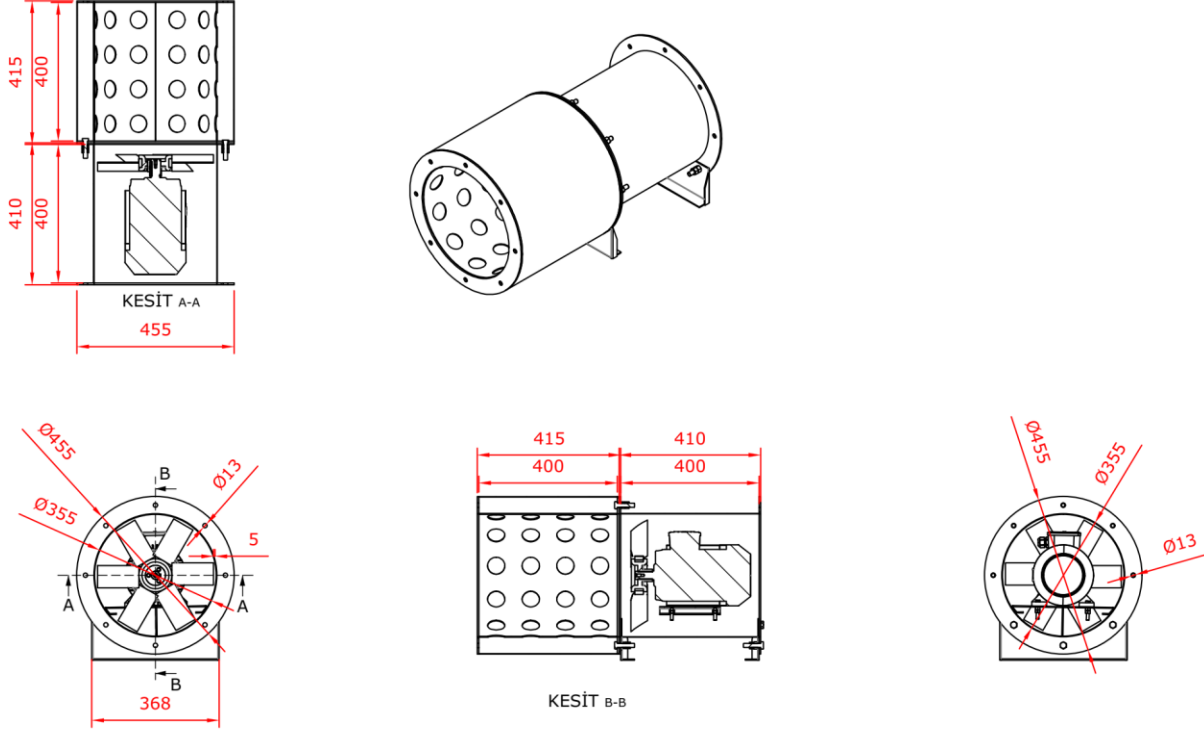
Figure 1: fan carcass details

- Overall diameter : 455 mm
- Inner diameter : 355 mm
- Outside length : 410 mm
- Wall thickness : 5 mm
- Carcase support : 2 steel plate legs were used to fix the fan frame.
 - Steel plate dimensions : 368 x 40 x 120 x 3 mm (w x d x h x t)
 - Fixing : M20 steel screws. (6 pcs.)

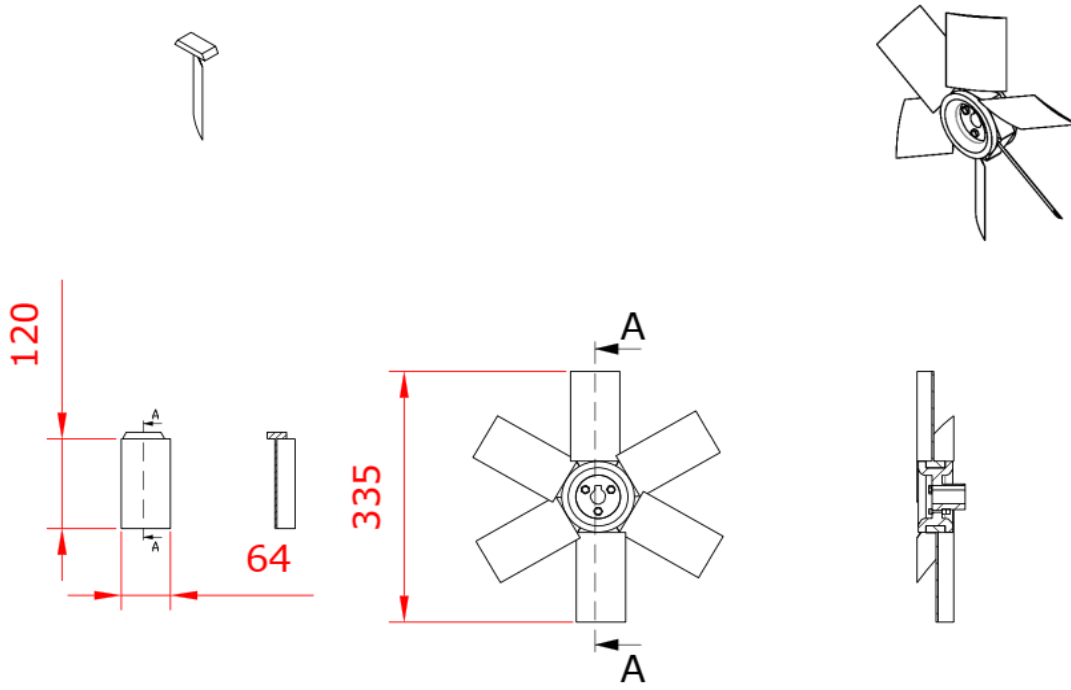
NOMİNAL BOŞLUK 8 MM

Figure 2: Impeller details

- Overall diameter : 335 mm
- Blade length : 120 mm
- Blade thickness : 3 mm
- Fastening : Each impeller placed inside to the hub casing and fixed with 3 pcs. nut.

- Declared nominal value : 8 mm
- Measured mean value : 8 mm

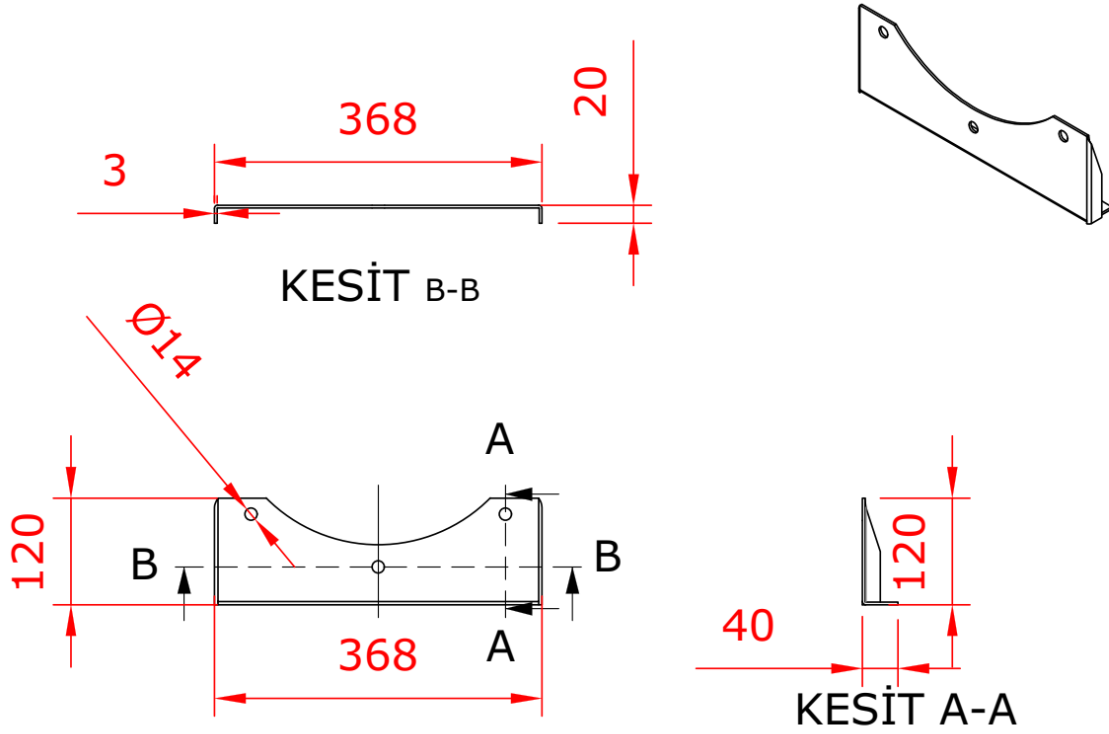
Figure 3: fan carcass details

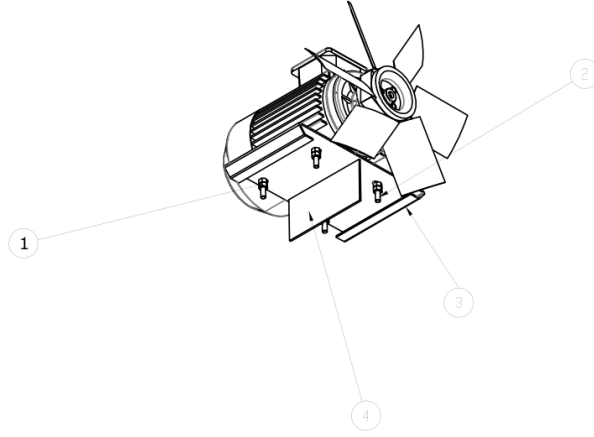
Figure 4: Motor connecting details

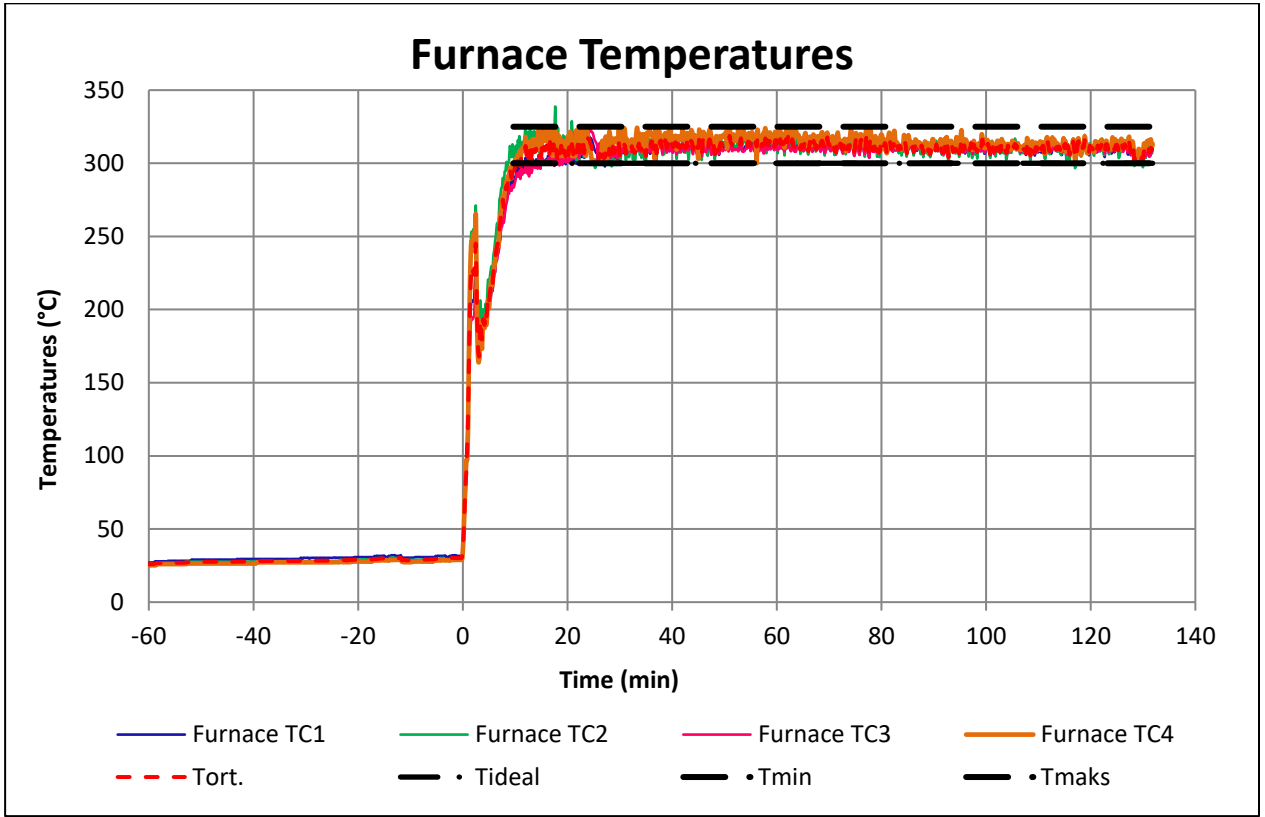
Figure A1: Furnace temperatures

- Air temperatures at the intake plane of the fan (Furnace TC1 to Furnace TC4) (see figure A1).
- Ambient temperature in the laboratory (see figure A3).
- Static pressure at the intake plane of the fan (see figure A2).
- Surface temperatures on the motor carcass (See Figure B2)
- Current of the motor (see figure B3)
- Supply voltage of the motor (see figure B4)
- Electrical power of the motor (see figure B5)
- The positions of the thermocouples on motor carcass are given in figure B1.

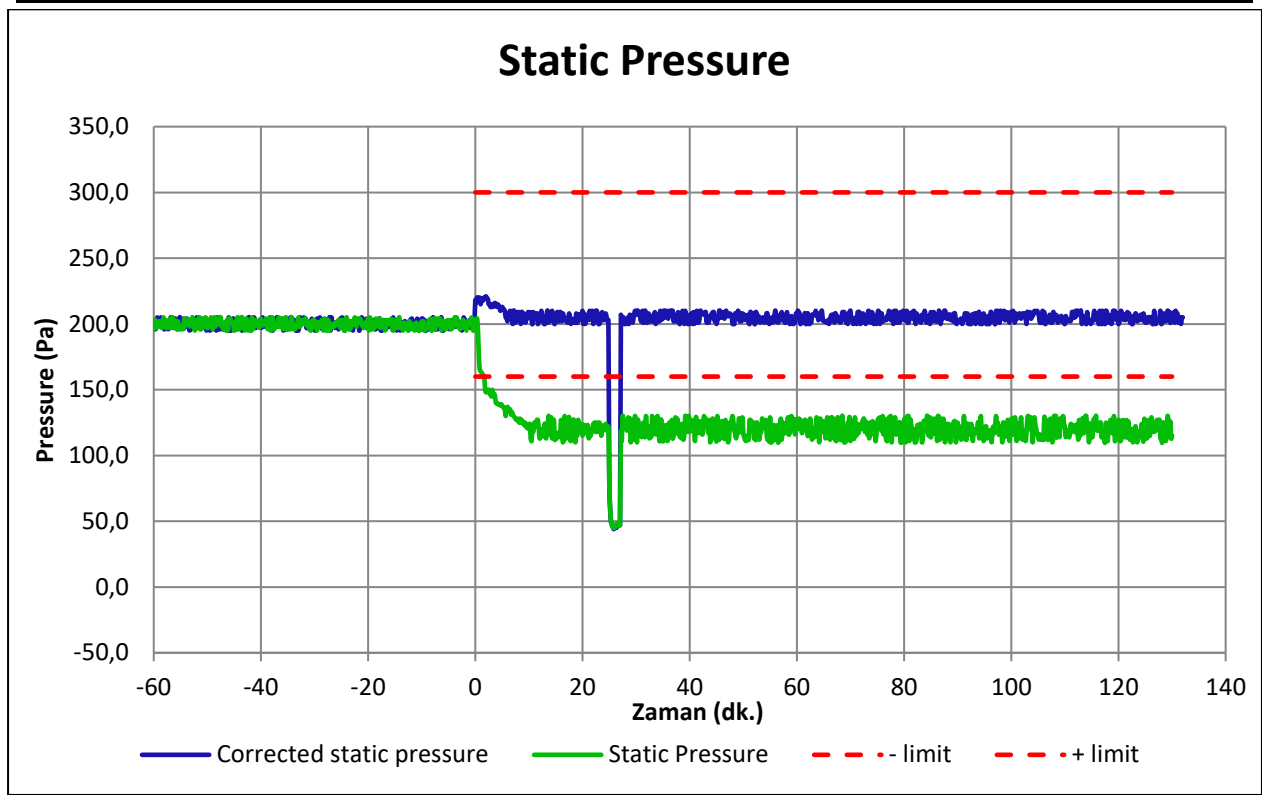
Figure A2: Static pressure of fan

Functionality, (F) – Static pressure – Motor	No failure (- %5,88) No failure
Test was terminated at 131 nd minute with approval of the sponsor.

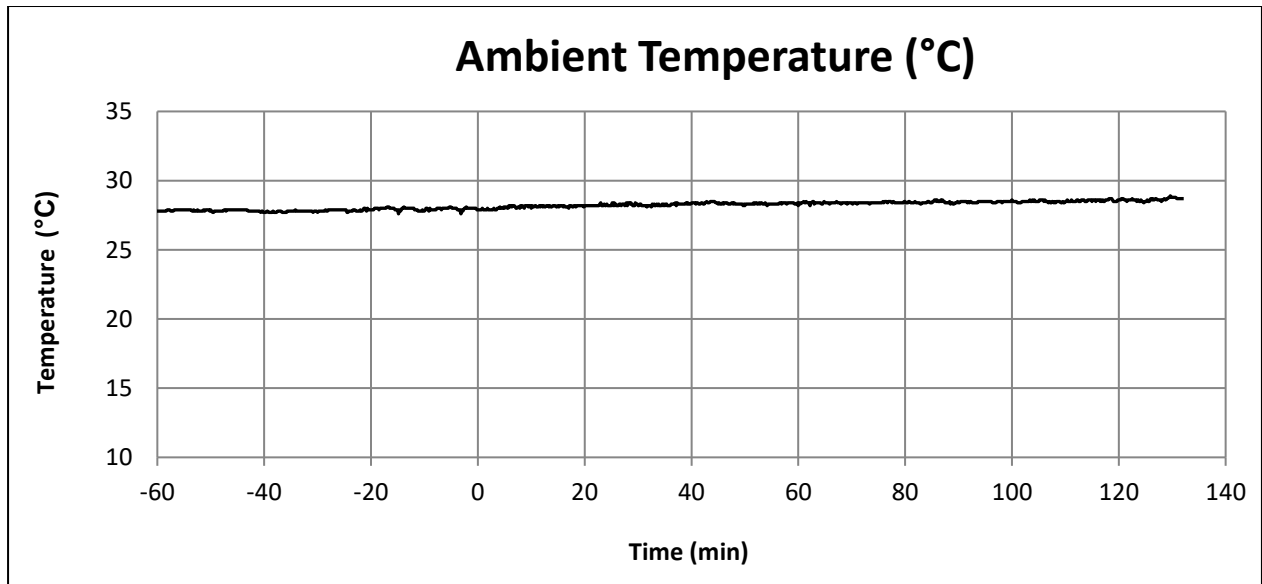
Figure A3: Ambient temperature at laboratory

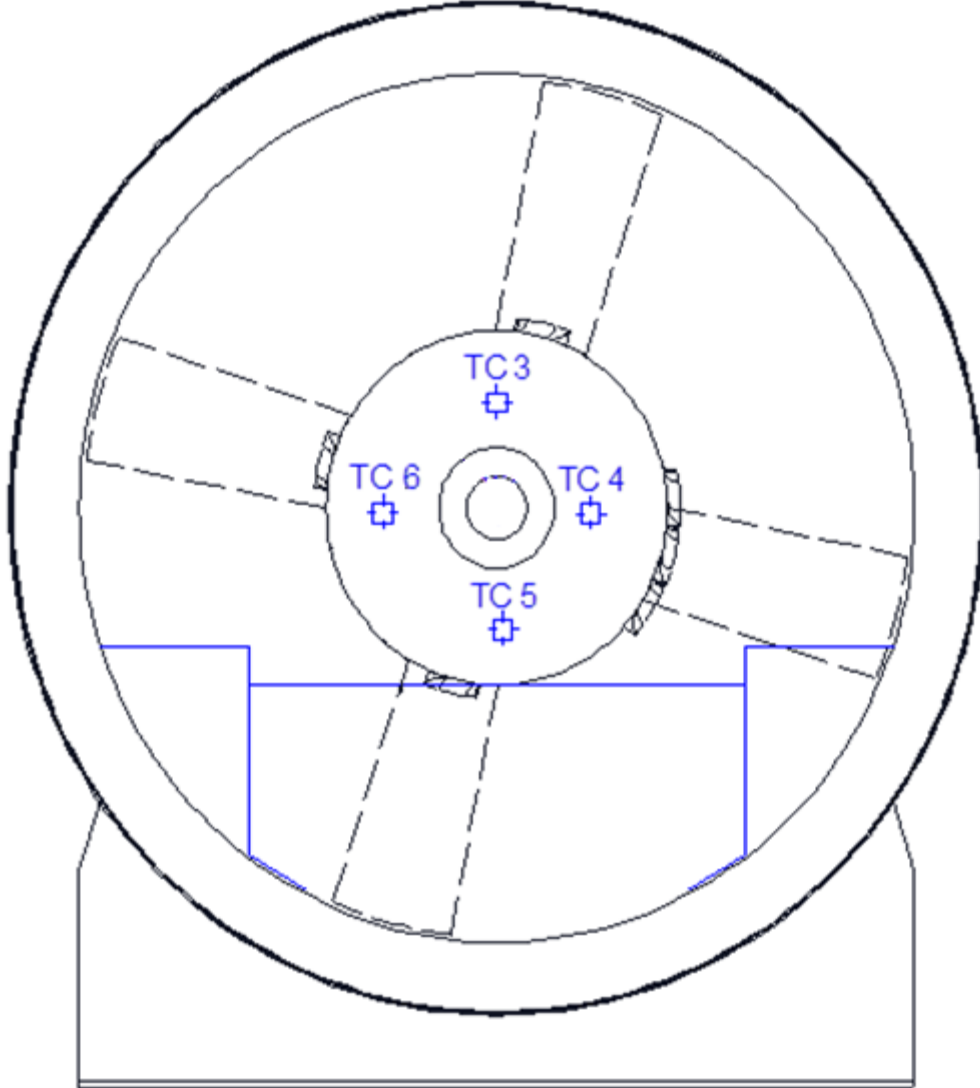
Figure B1: Locations of thermocouples on the motor carcass

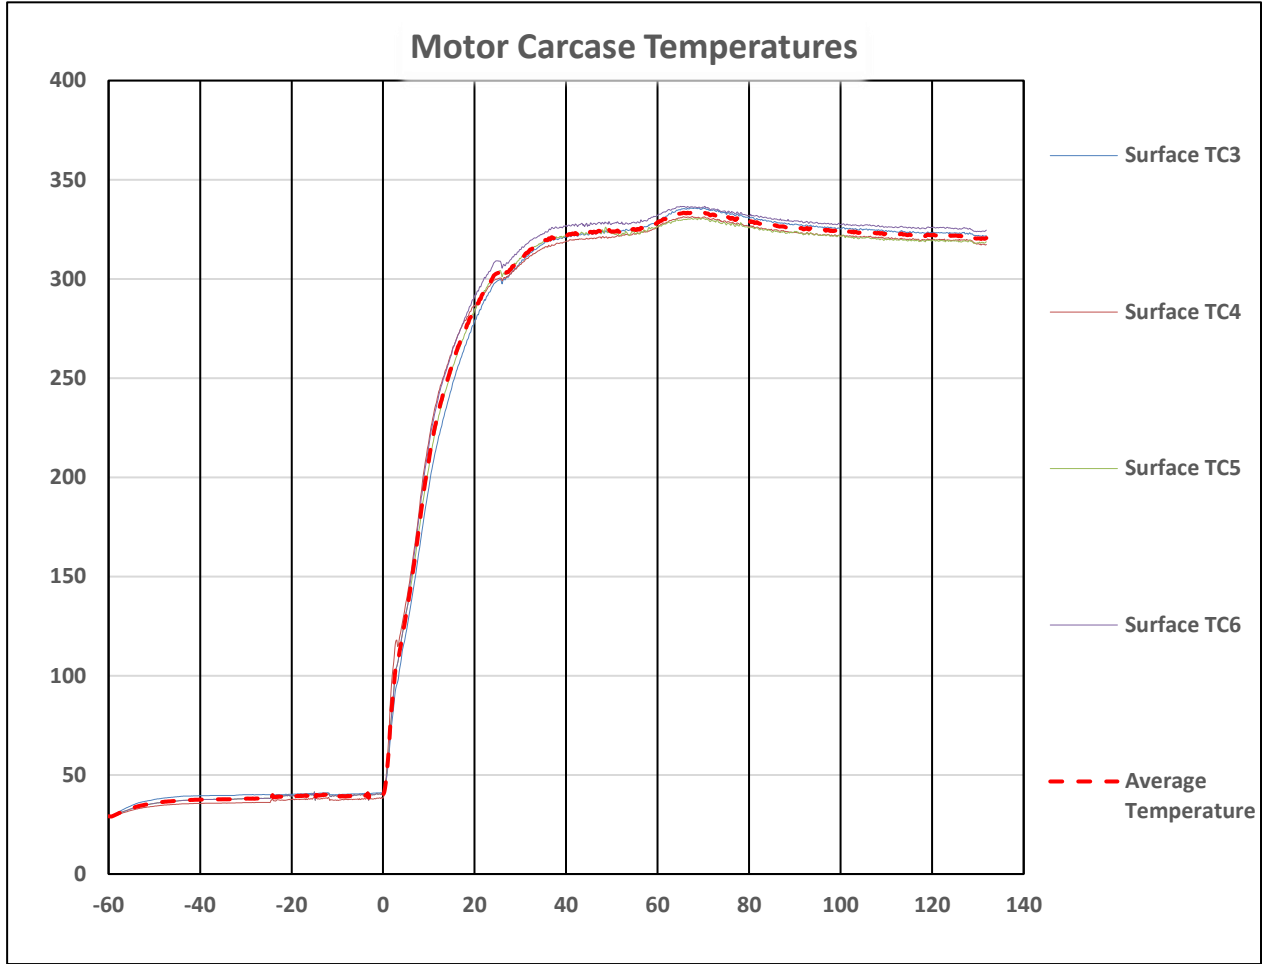
Figure B2: Surface temperatures on motor carcass

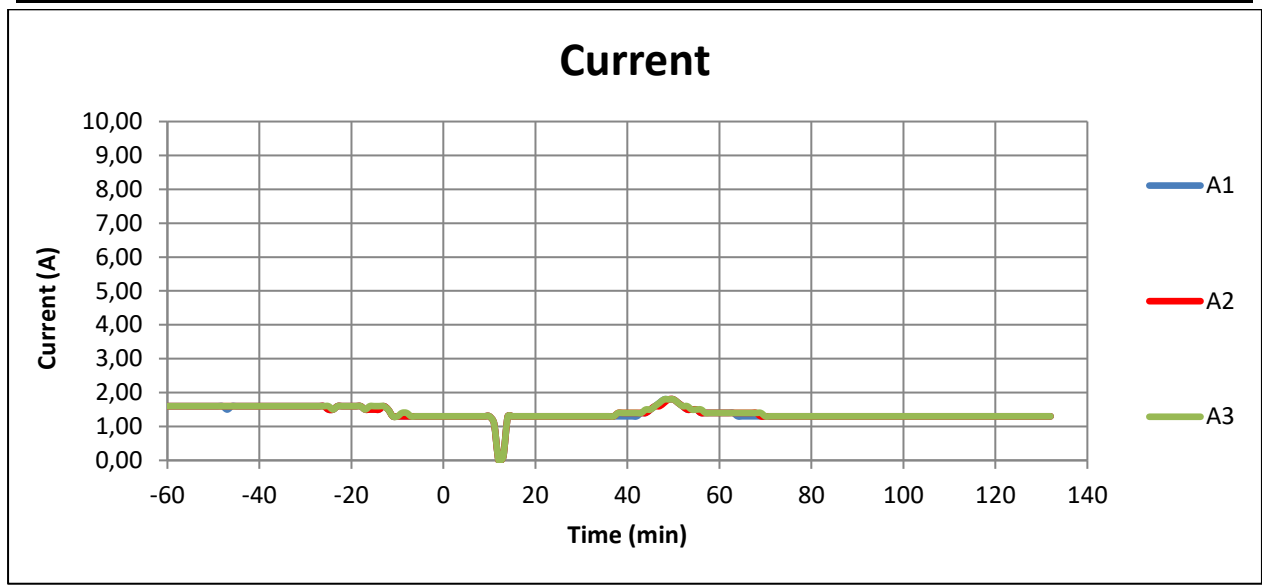
Figure B3: Motor current reading during test

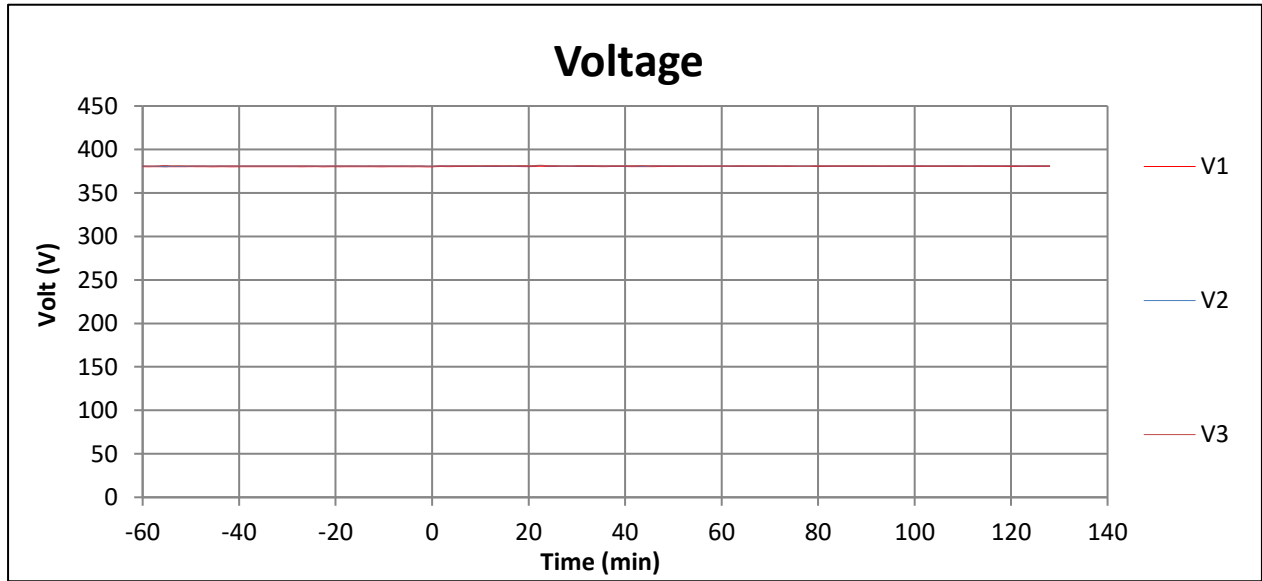
Figure B4: Motor voltage reading during test

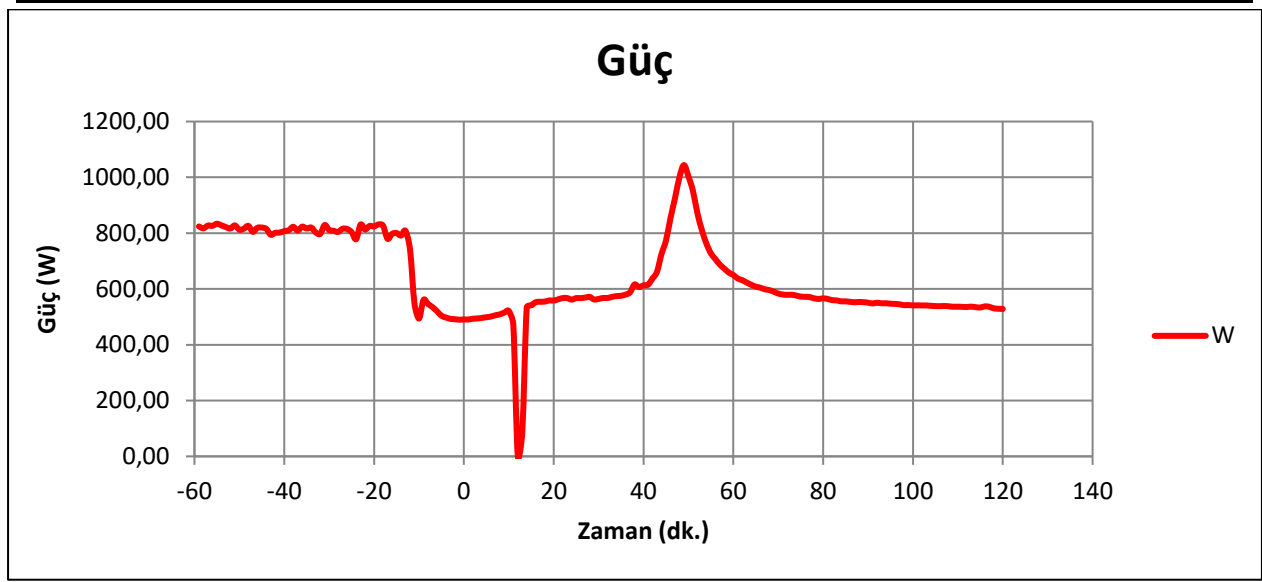
Figure B5: Motor power reading during test

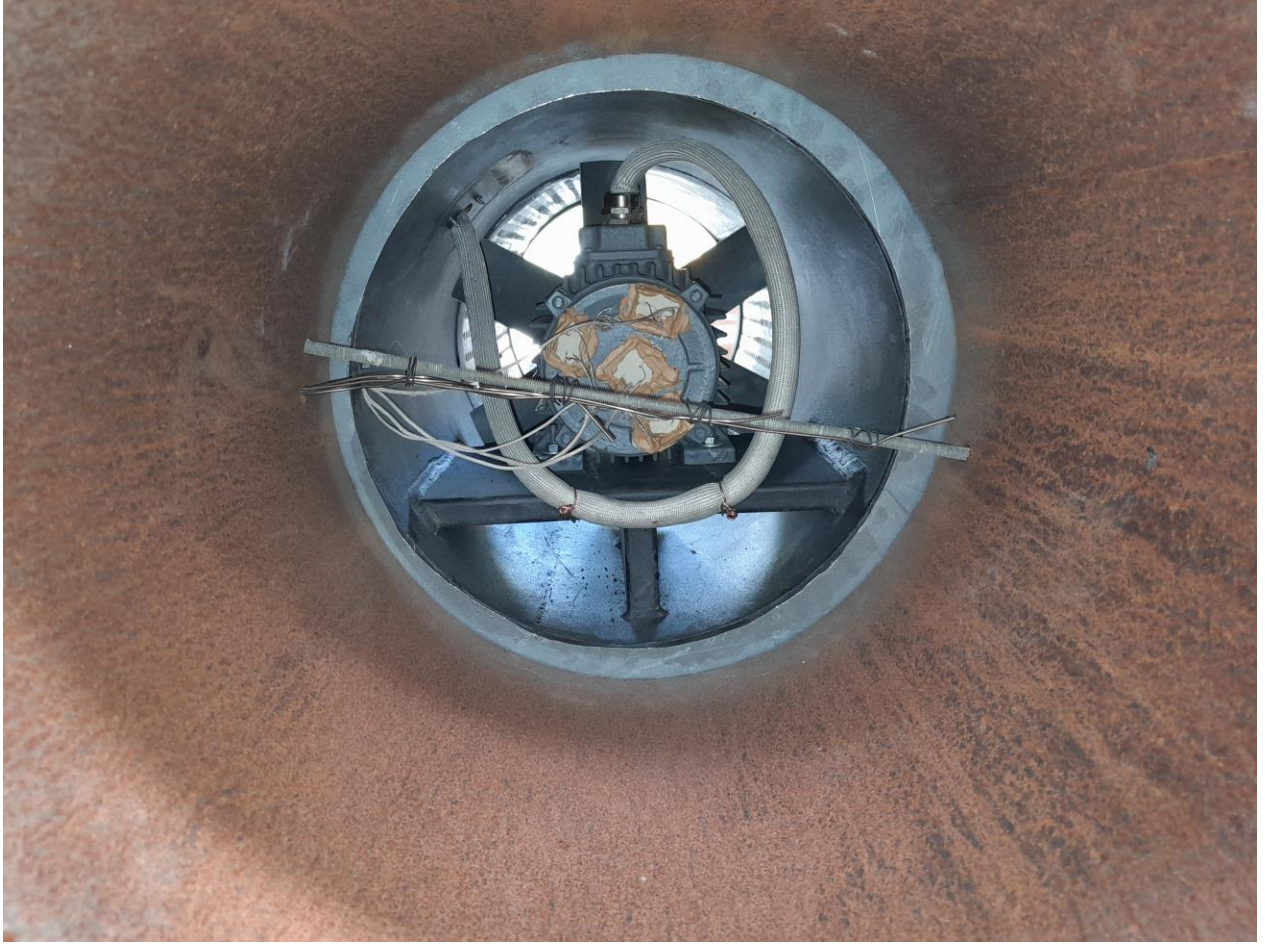
Photo C1: Rear view of the specimen before the test

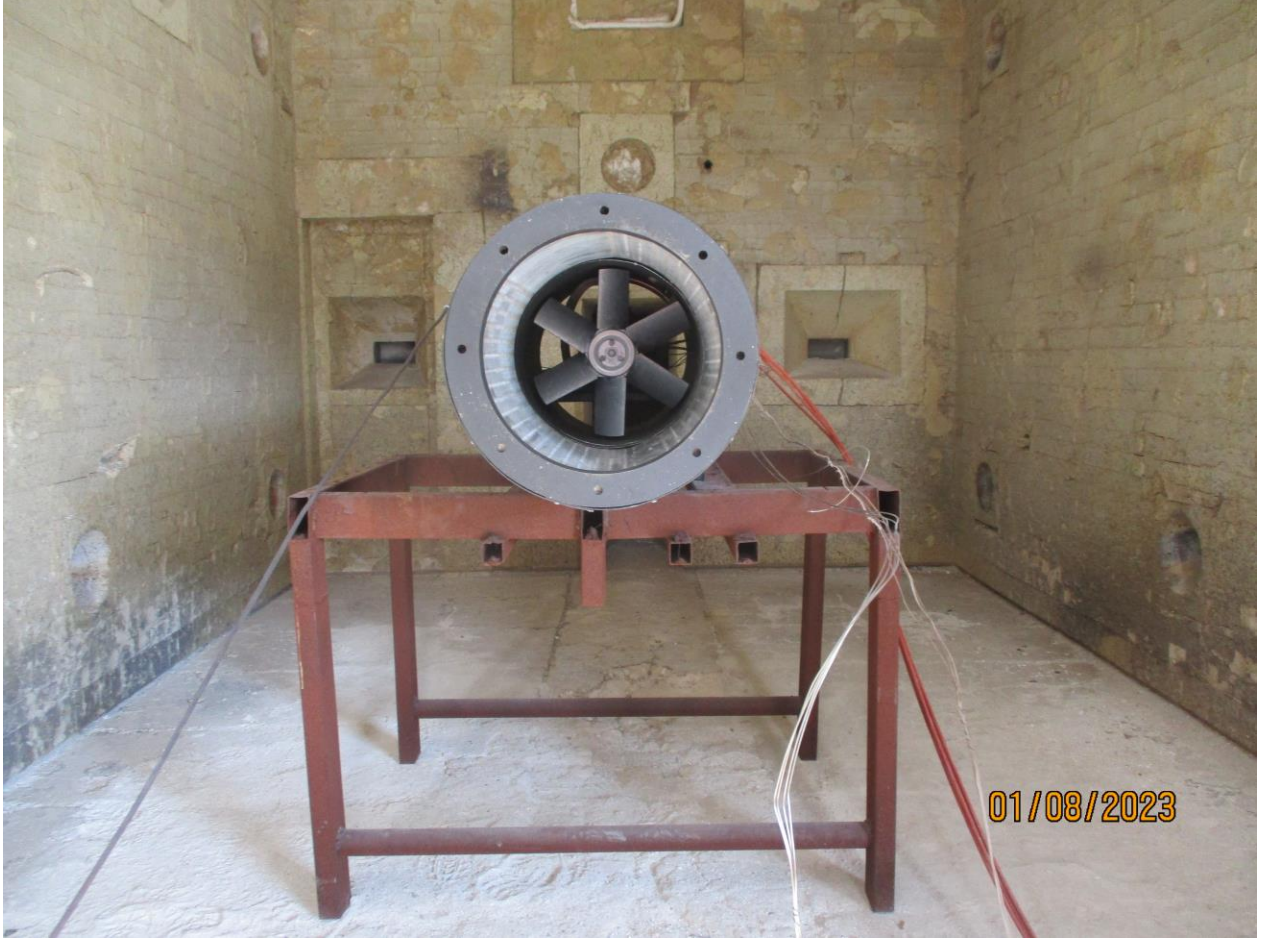
Photo C3: Front view of the sample after testing
